TEST REPORT No. 370570

railing named**“ALURAIL FLORA CROCUS 8030 SIDE WITH GLASS 66.2 PVB”**

**horizontal linear static loading in accordance with
standard UNI 10806:1999 and DM Infrastrutture
17 January 2018, and 50 kg soft body dynamic loading in
accordance with standard NF P01-013:1988**

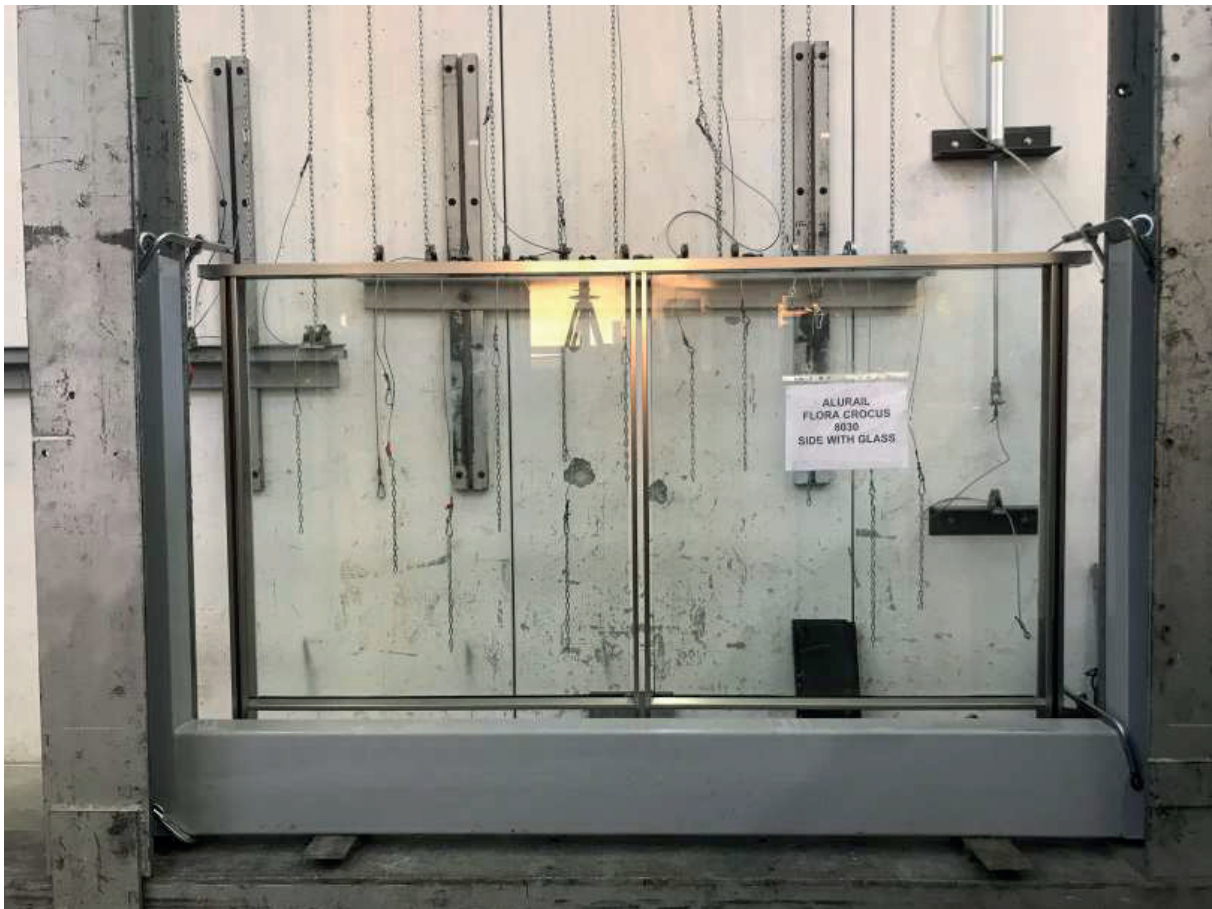
The item under evaluation consists of a laminated glass railing with aluminum structure, having the characteristics shown in the following table.

Width		2130 mm
Height from floor level		1100 mm
Tempered glass type		66.2 (PVB)
Glass dimensions	width	940 mm
	height	1080 mm

Item photograph

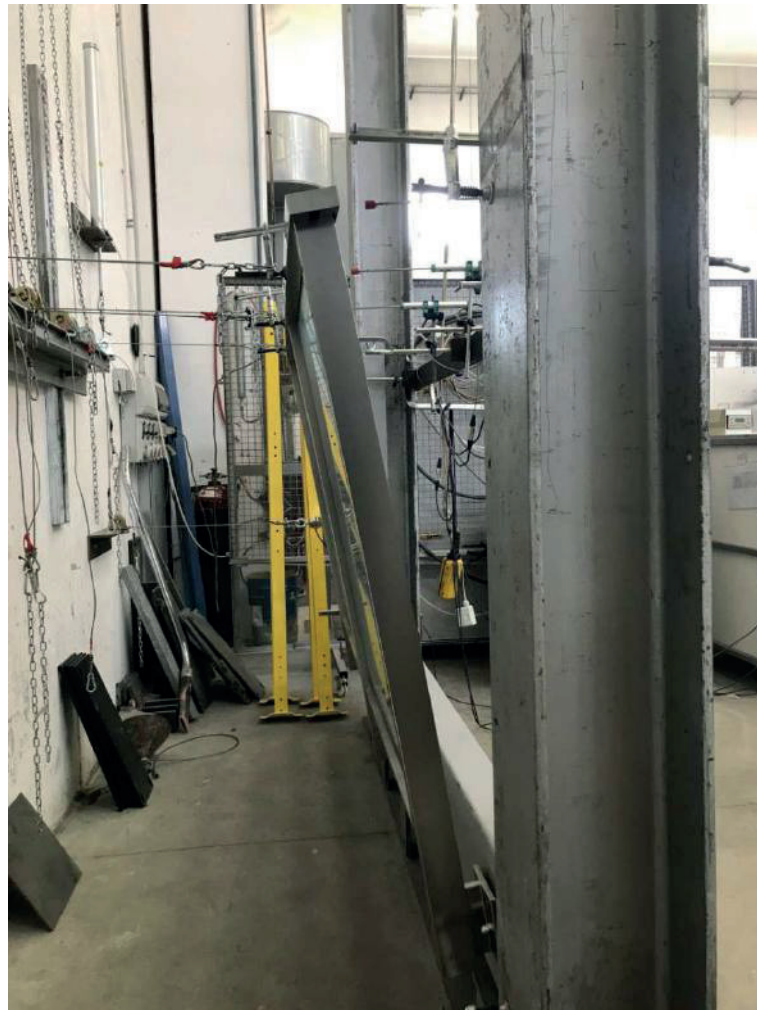
Applied load per unit area [kN/m]	Deflection under load at the measure point			Residual deformation at the measure point			Effect
	A [mm]	B [mm]	C [mm]	A [mm]	B [mm]	C [mm]	
2,0	180	184	185	58,3	59,3	58,7	no damage impairing item functionality

Photograph of the item subjected to horizontal linear static load

Horizontal linear static loading

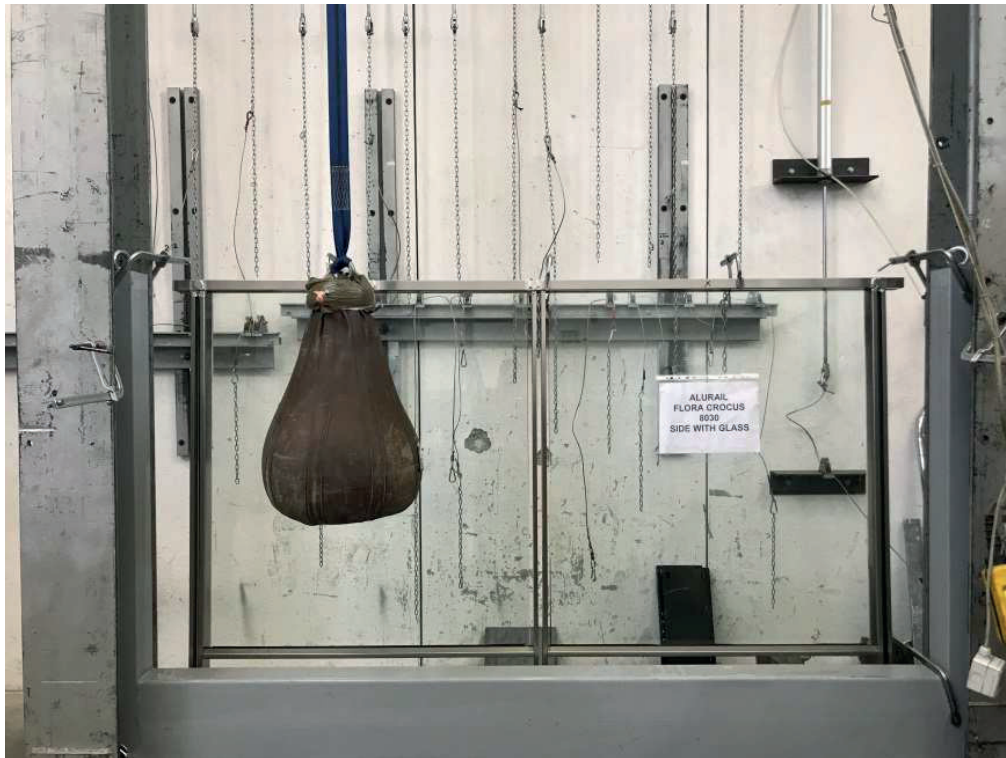
Impact area	Drop height [m]	Energy [J]	Result
infilling centre	1,2	589	no damage*

(*) No falling fragments that could cause personal injury were found below.

No gaps were formed between the bars of sufficient size to allow the passage of the gauge specified in figure 7 of standard NF P01-013:1988.

No sample performance loss compared to design specifications was witnessed.

Item photograph after the impact
