TEST REPORT No. 370572

railing named "ALURAIL FLORA LOTUS 8015 TOP"

horizontal linear static loading in accordance with standard UNI 10806:1999 and DM Infrastrutture 17 January 2018, and 50 kg soft body dynamic loading in accordance with standard NF P01-013:1988

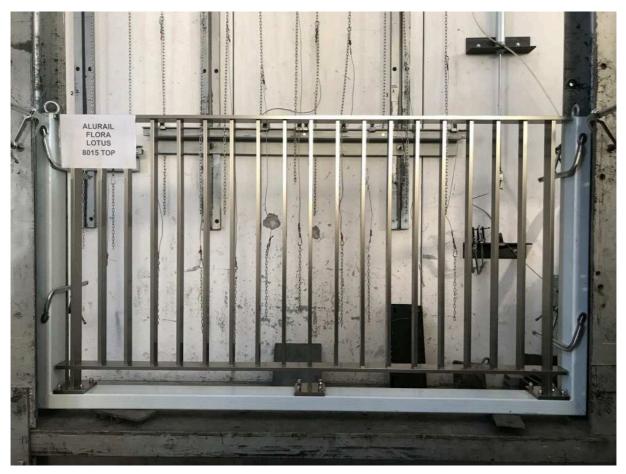
Item photograph

Width	2015 mm
Height from floor level	1100 mm

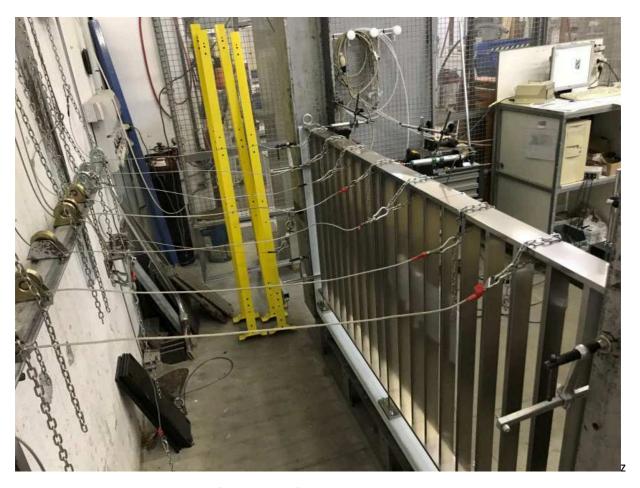
Photograph of the item before horizontal linear static loading

Horizontal linear static loading

Applied load per	Deflection under load at the measure point		Residual deformation at the measure point			Effect	
unit area	Α	В	С	Α	В	С	
[kN/m]	[mm]	[mm]	[mm]	[mm]	[mm]	[mm]	
2,0	42	47	45	1	1	2	no damage impairing item functionality

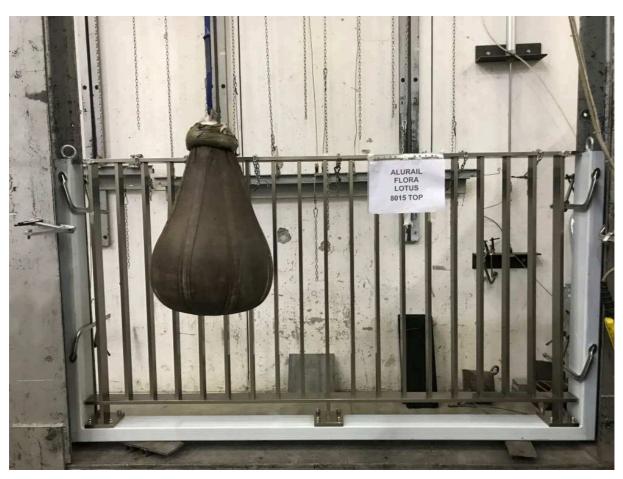
Item photograph after the impact

Resistance to dynamic impact

Impact area	Drop height	Energy	Result
	[m]	[J]	
infilling centre	1,2	589	no damage*

^(*) No falling fragments that could cause personal injury were found below.

No gaps were formed between the bars of sufficient size to allow the passage of the gauge specified in figure 7 of standard NF P01-013:1988.

No sample performance loss compared to design specifications was witnessed.

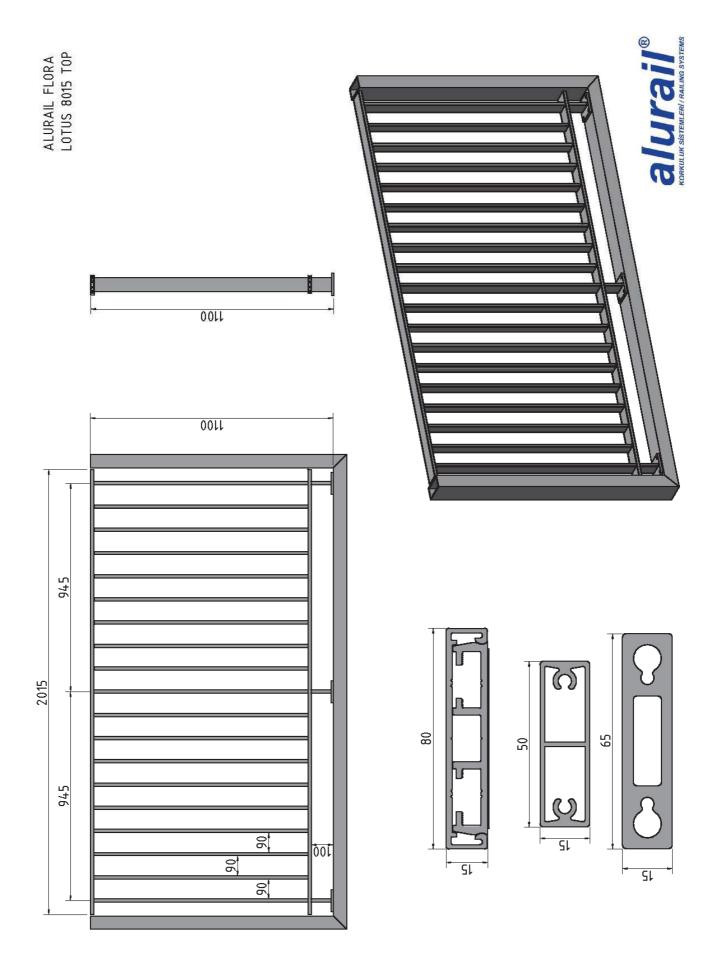
ANNEX "A" TO TEST REPORT No. 370572

technical documentation

Further details of item specifications can be seen in customer-supplied schematic drawing in annex "A".
