## TEST REPORT No. 342593

**Purpose of test:** resistance to horizontal linear static loading according to D.M. Infrastrutture dated 14/01/2008 and standard UNI 10806:1999 and resistance to dynamic loading according to standard UNI 10807:1999

The test sample is called "RAILING X50".

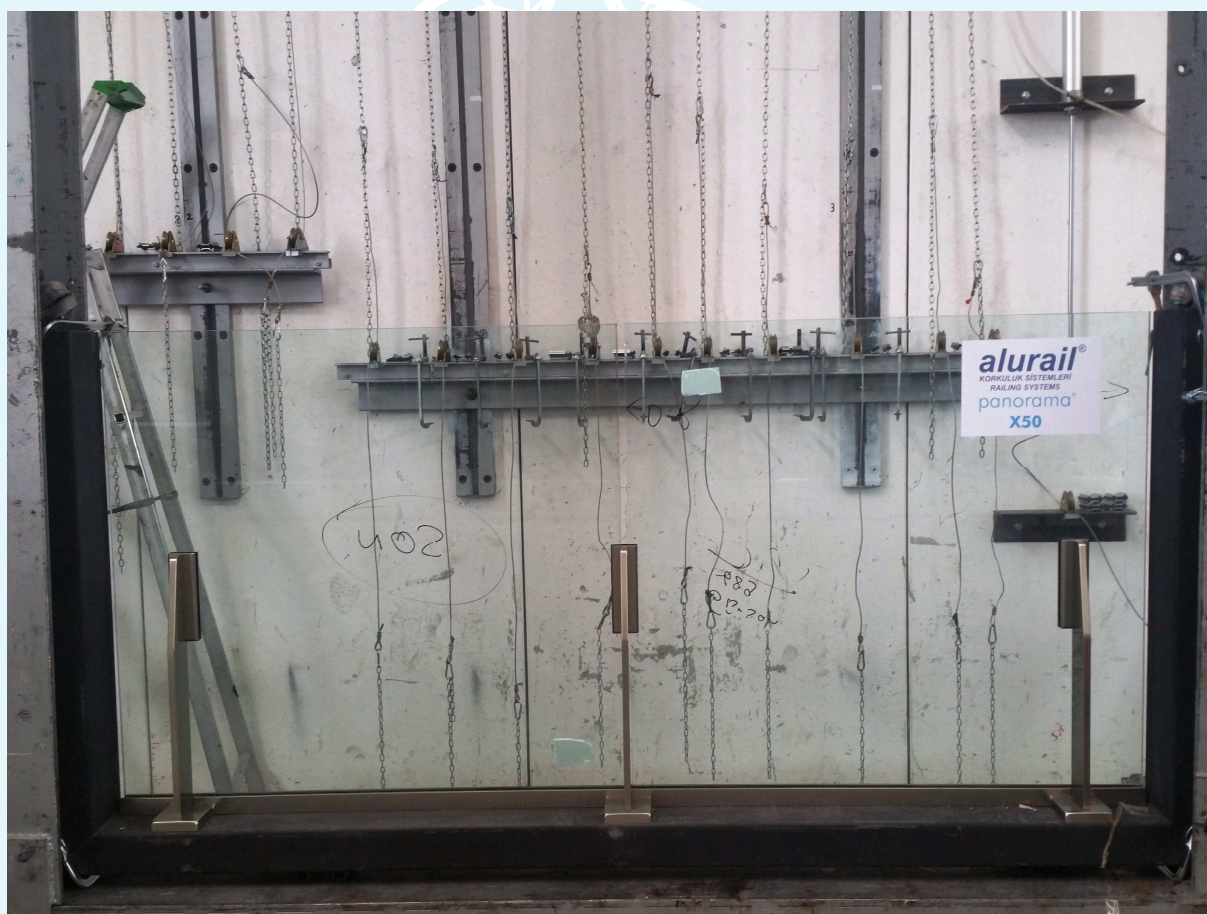
The test sample consists of a tempered glass railings with aluminum structure having the characteristics shown in the following table.

<b>Width</b>		2310 mm
<b>Height from floor level</b>		1100 mm
<b>Tempered glass type</b>		88.4 (PVB)
<b>Glass dimensions</b>	<b>width</b>	1147,5 mm
	<b>height</b>	1077 mm

**Sample photograph.**

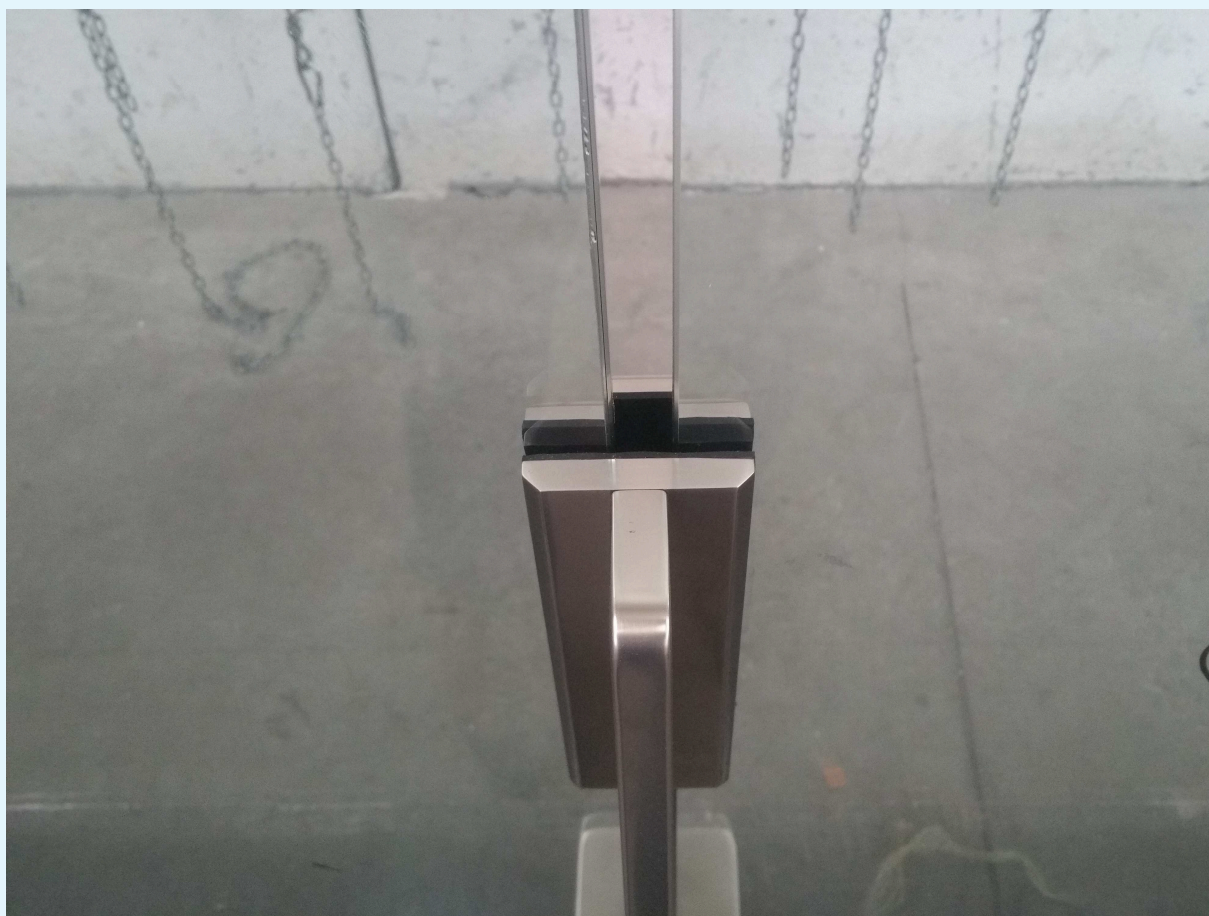
Detail.

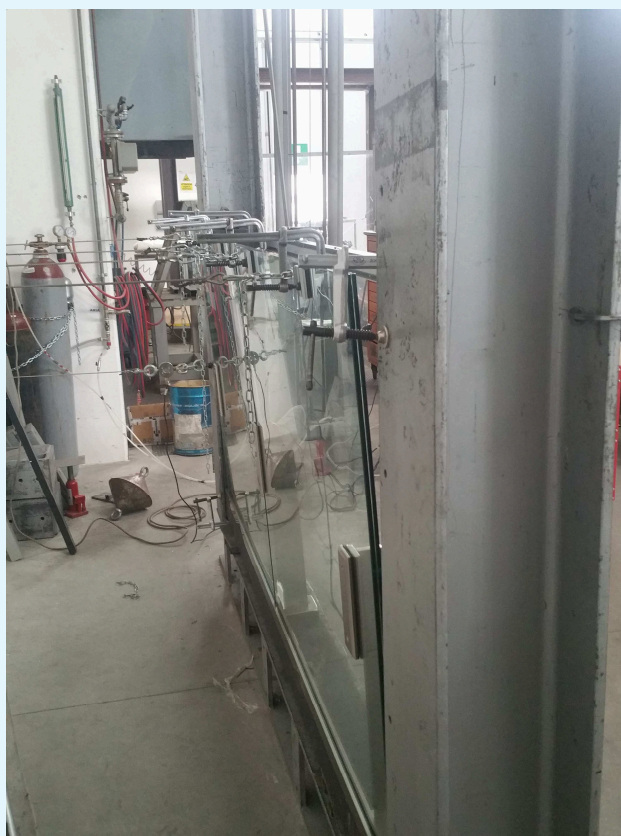
Applied load for unit length	Deformation whilst loaded		Permanent deformation		Effect
	A	B	A	B	
[kN/m]	[mm]	[mm]	[mm]	[mm]	
1,0	68,1	70,3	6,6	4,1	no damage

**Photograph of the sample subjected to horizontal linear static loading.**

The sample was subjected to horizontal linear static load apportioned, as defined by the Costumer, on the upper edge of the plate.

Test	Normative reference	Requirement	Result
Horizontal linear static load	D.M. Infrastrutture dated 14/01/2008 (table 3.1.II)	1,0 kN/m	Compliant with all categories except C3*
Dynamic load	UNI 10807	150 J	Compliant

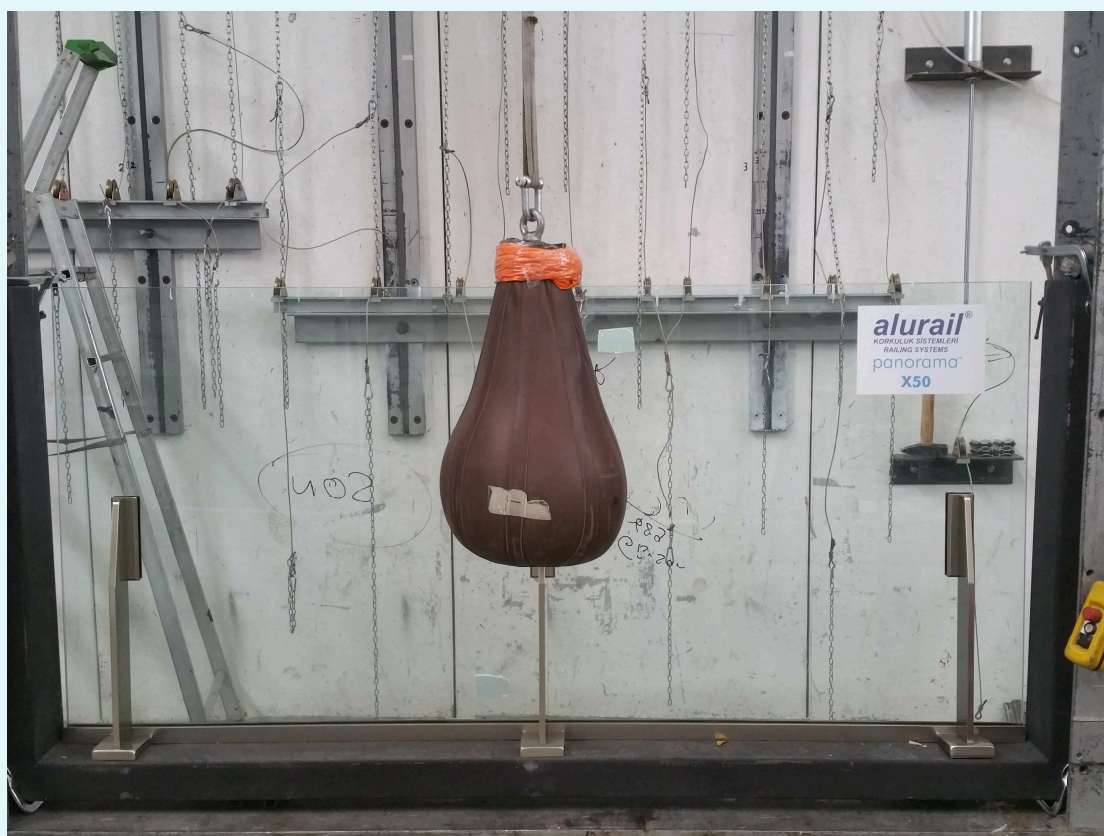
Impact area	Drop height [mm]	Nominal energy [J]	Result
centre of infill	300	150	no damage

**Photograph of the sample after the impact.**

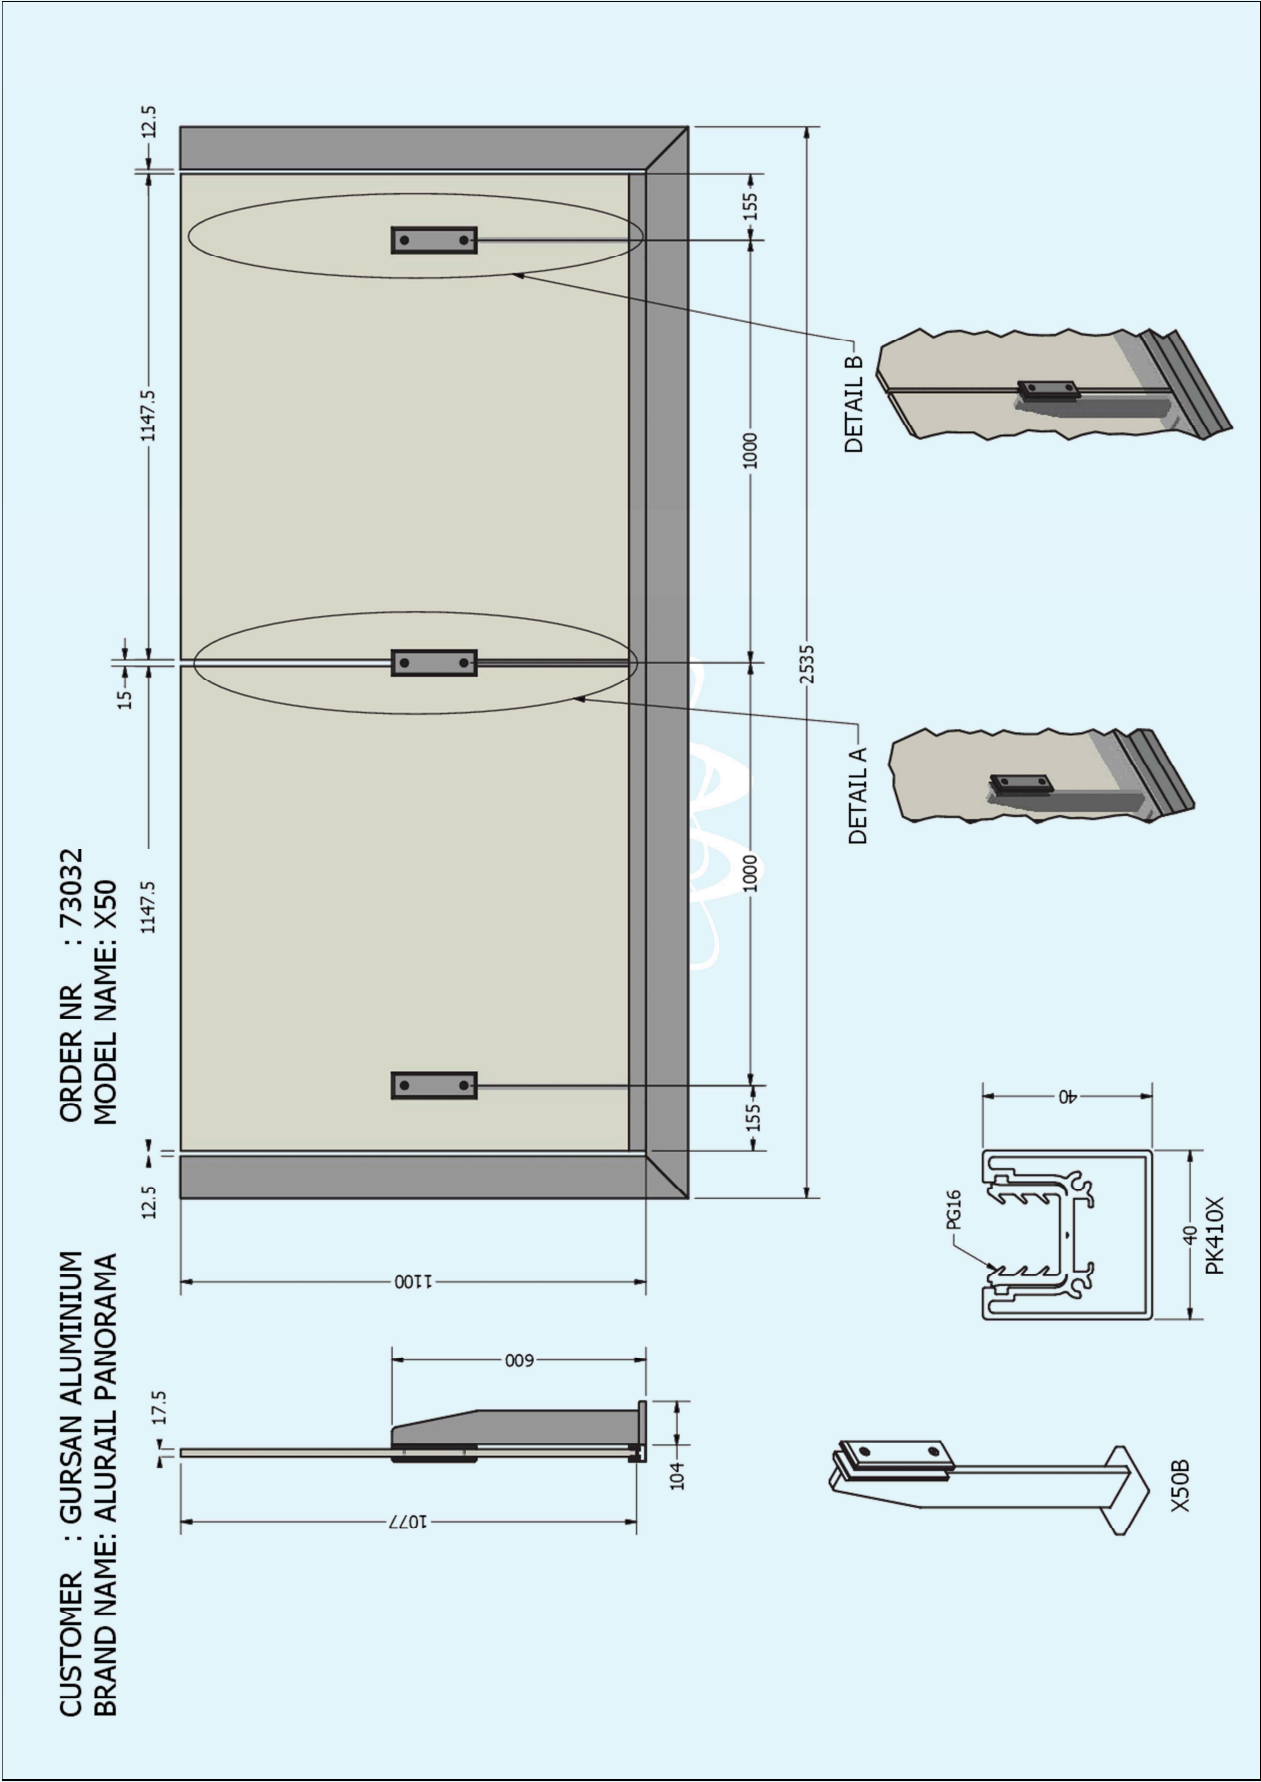
In the following sheet is shown Customer-supplied schematic drawing related to the sample.

Further details of sample specifications can be seen in Customer-supplied schematic drawings shown in annex "A" to this test report.
